Failure Analysis of Three Si_3N_4 Balls Used in Hybrid Bearings

15 February 2003

M. J. O'BRIEN,¹ N. PRESSER,² and E. Y. ROBINSON³

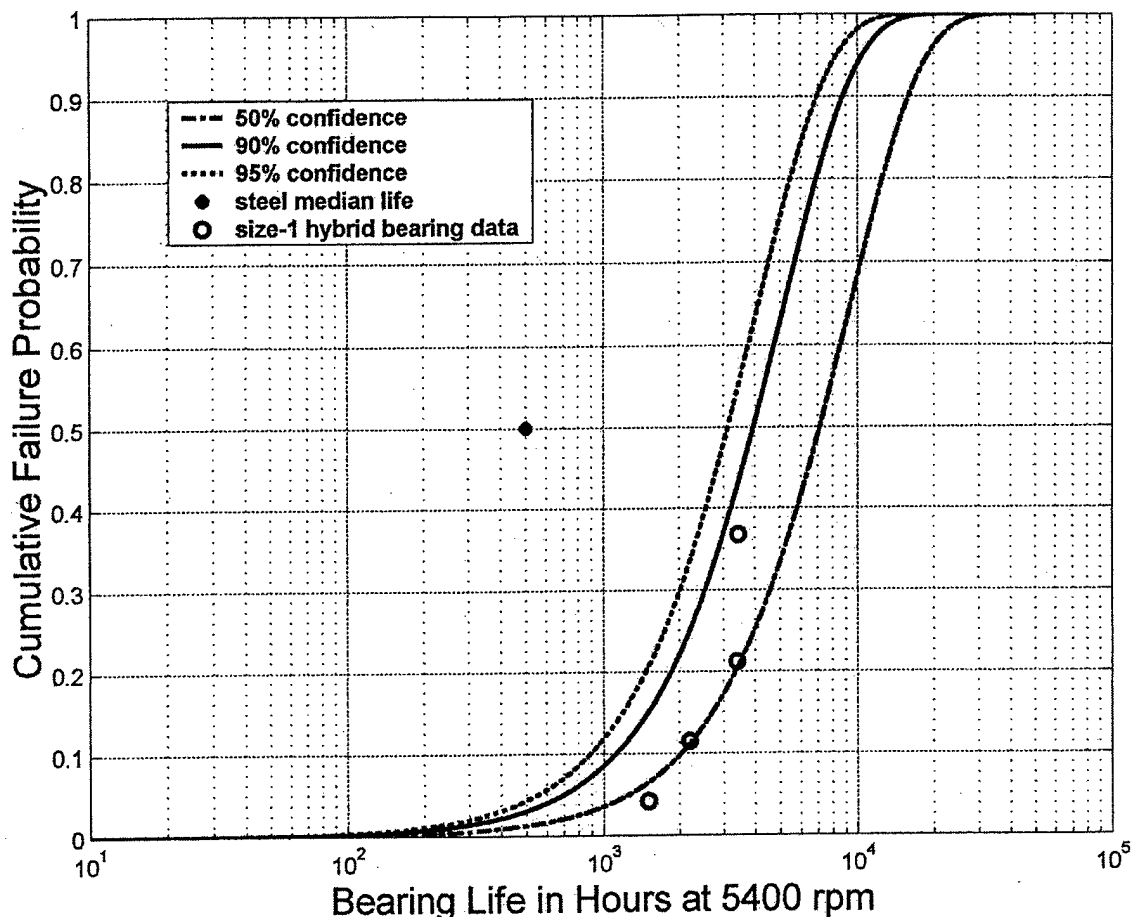
Figure 1. Projected fatigue life of type 207H silicon-nitride hybrid bearings at 13,300 N load and 5400 rpm shaft speed.

where F_j is the cumulative probability of failure, j is the rank number, and N is the total sample size. These are shown in Table 1. Equation (3) allows the ranking and plotting of failure probabilities for single bearings. The values in Table 1 are used below in Subsection 3.2.5 to plot the individual experimental data points from Subsection 3.1 on the failure probability chart shown in Figure 1.

The distributions from Eq. (16) are plotted in Figure 1. The quantity plotted is the cumulative failure probability, which is, of course, equal to $1 - S$. The distributions at the 50%, 90%, and 95% confidence levels are obtained by inserting the respective median lives of 7130, 3954, and 3130 h into T_r in Eq. (16). Also plotted in Figure 1 are the experimental data points for the steel and hybrid bearings. As mentioned above, the values from Table 1 allow the ranking and plotting of the hybrid bearing data.

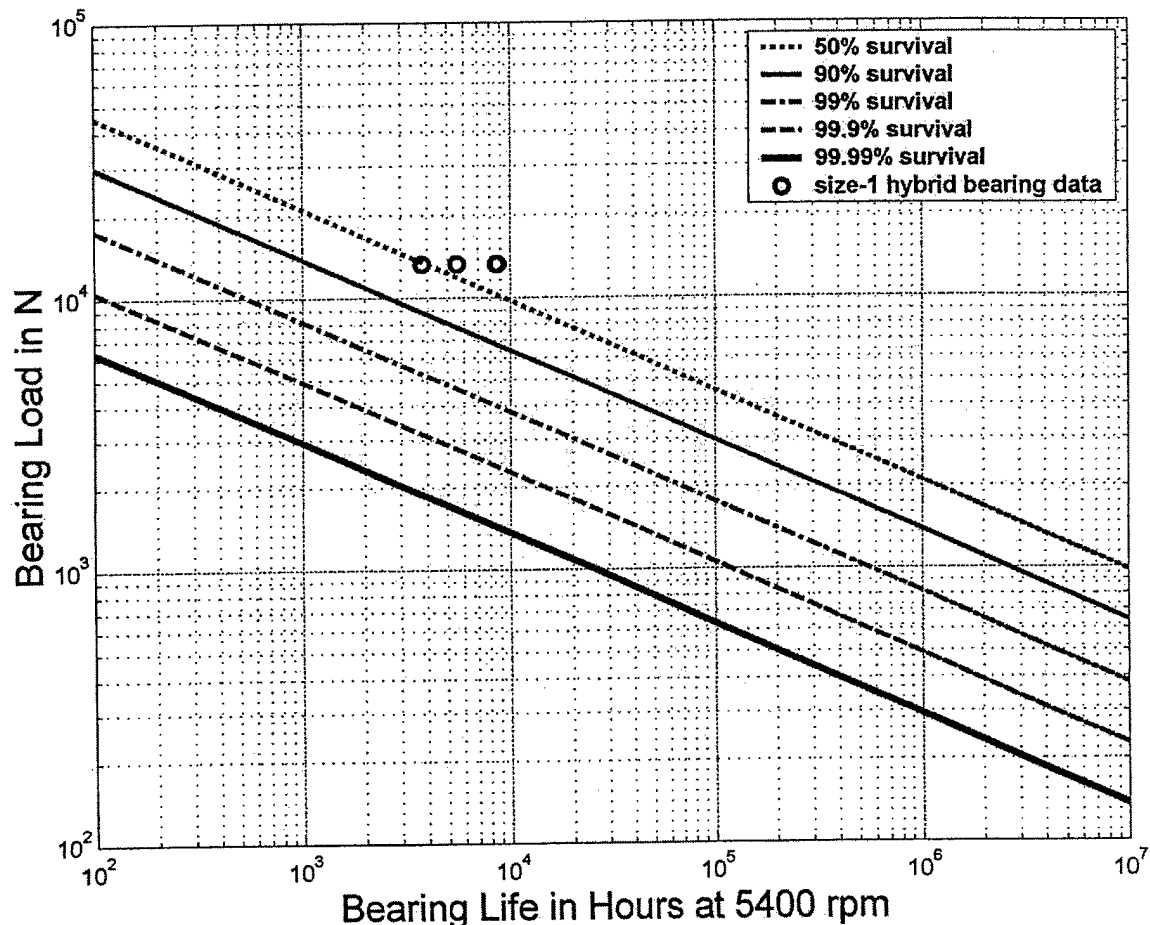
Figure 2. Bivariate Weibull fatigue design model for type 207H silicon-nitride hybrid bearings at 5400 rpm shaft speed and 90% confidence level.

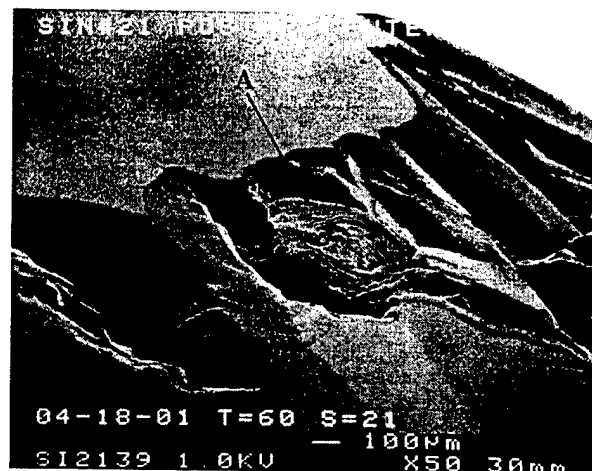
Figure 3 is a low-magnification view of the entire spall from a perspective perpendicular to the surface. The Wallner lines radiate on the left and right from an initiation site labeled "A," with the concave sides of the Wallner lines pointing back towards this initiation site, which is a broad, flat "plateau." Figure 4 is a more highly magnified view centered to the left-hand side of the initiation site "A," and Figure 5 is a companion view centered to the right-hand side. Figures 4 and 5 are taken at oblique angles to highlight the concave Wallner lines, which again are seen to point back towards the site "A," which is, therefore, identified as the initiation site.

Figure 4. View centered to the left-hand side of the initiation site "A."

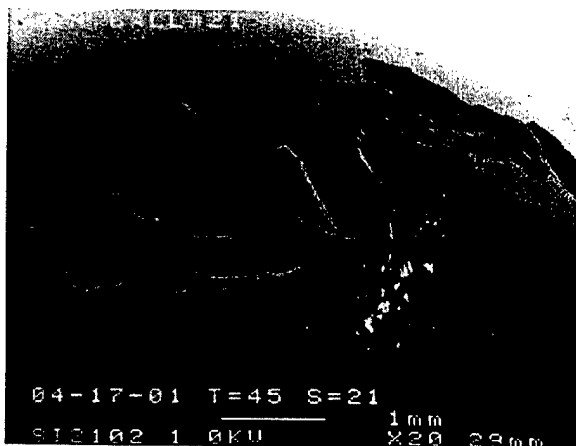
Figure 5. Companion view centered to the right-hand side of the initiation site "A" (this view is upside down from the previous view).

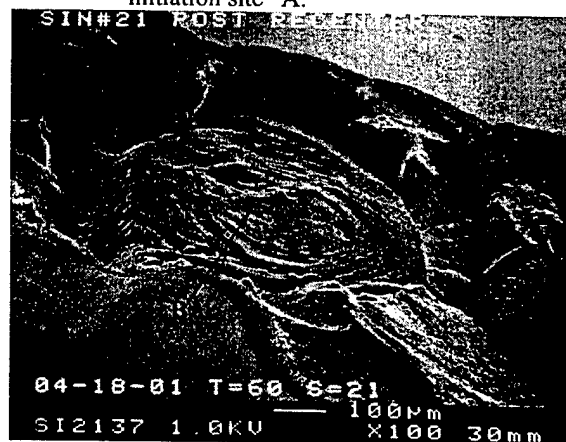
Figure 6 is a more highly magnified view (at 100x) centered on the site "A" from an oblique perspective. The circular Wallner lines seen in site "A" form a "bull's eye" pattern around a central point, labeled "B." The pattern of Wallner lines implies that the site "B" is the upstream location where failure initiated. Detailed inspection of site "B" at still higher magnifications did not seem to reveal a clear cause for the initiation of the fracture.

Figure 6. View centered on the initiation site "A" showing a central "bull's eye" pattern of Wallner lines.

The fractographic analysis of the first Si_3N_4 ball in Subsection 3.3.1 identified the initiation site for the failure, but did not identify the microstructural feature responsible for the initiation. It is possible that the microstructural feature did not survive the failure.

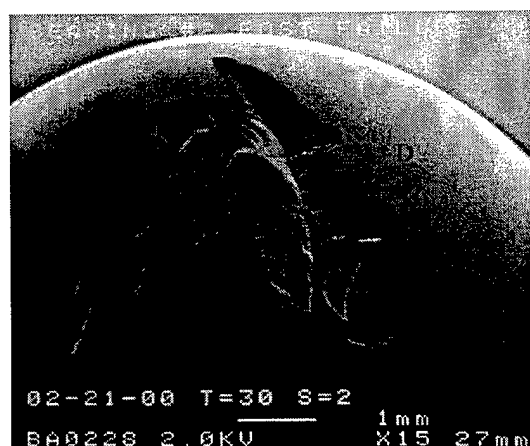
Figure 7 is a low-magnification view of the entire spall. To orient the discussion of subsequent fractographs that show finer detail, five features are labeled in Figure 7. In this view, the circular Wallner lines are evident in the upper and left-hand parts of the spall. In particular, feature "A" is a region of Wallner lines in the middle of the spall. Feature "B" is a region of Wallner lines upstream from feature "A." The concave lines radiate back to a point labeled "C," which is a void in a triangular pocket defined by the intersection of three cracks. (In the following more highly magnified fractographs, feature "C" is shown to be a void). The long feature labeled "D" is a deep "trench-like" fracture. An interesting feature, labeled "E," is a patch of virgin surface that did not spall away.

Figure 7. View of the entire spall.

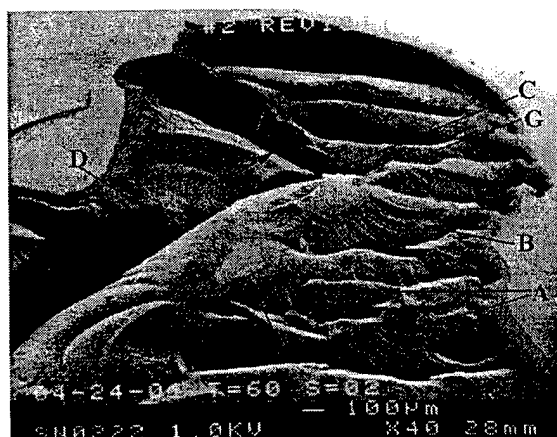
Figures 8 and 9 are low-magnification views taken by successively rotating the line of sight. The concavity of the Wallner lines, labeled "A" and "B," again reinforces that fracture initiated in an upstream location in the neighborhood of the feature "C," from which radiates the deep fracture "D." Two other cracks, labeled "F" and "G," also radiate from the feature "C." To provide a landmark, the location of the unspalled virgin surface is labeled "E."

Figure 8. View from an oblique perspective of Wallner lines downstream from the initiation site, "C."

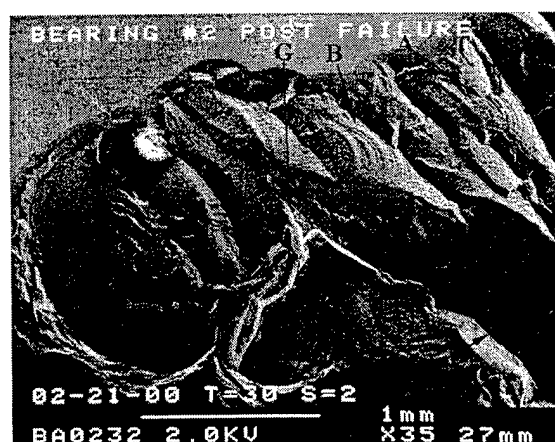
Figure 9. View of from an orthogonal perspective Wallner lines downstream from the initiation site, "C."

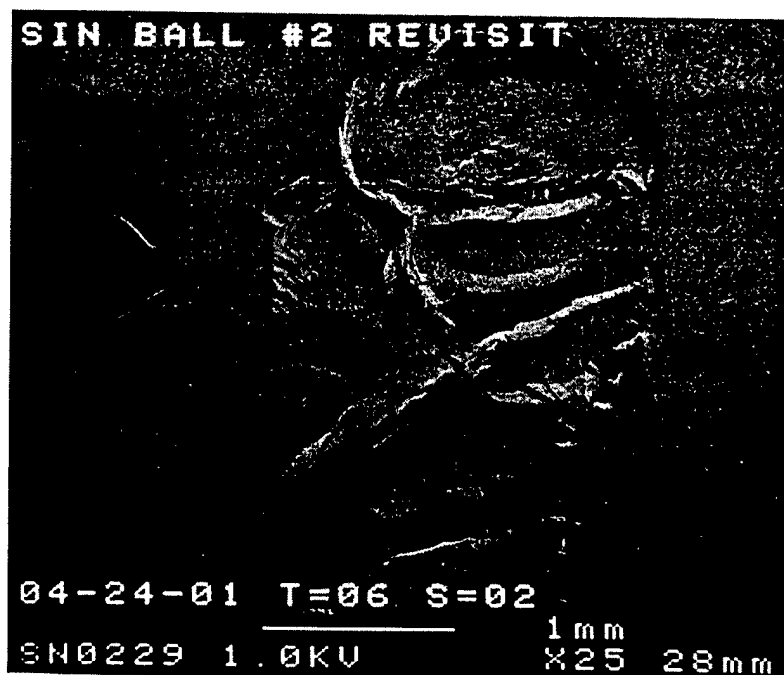
Figures 10, 11, and 12 are progressively higher magnification views (at 25x, 180x and 3500x, respectively) from an orthogonal perspective and centered on the feature labeled "C," which is revealed to be a void in a triangular pocket at the junction of the three cracks, "D," "F," and "G." Figure 13 is a view of the void from a different perspective that "sights" down the bore of the void. The void, which is approximately 2 μm in diameter, may be a small sintering pore where the ceramic did not fully densify. Figure 14 is a micrograph at a slightly elevated accelerating voltage, 3 kV, that shows that the region immediately around the void charges, although material further away does not. The discussion section expands upon the possible significance of the observed charging.

Figure 10. First in a series of three views centered on the initiation site, "C," from which three cracks radiate.

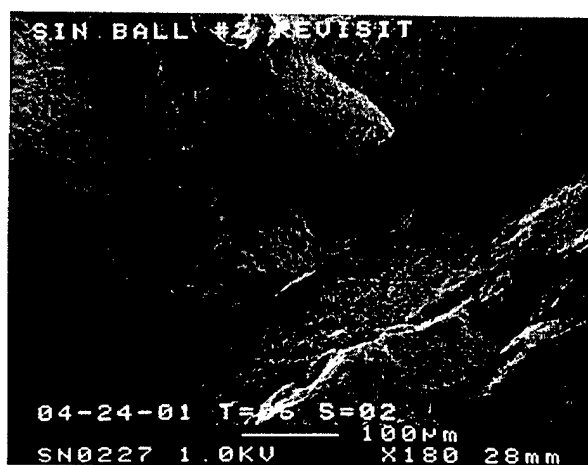
Figure 11. More highly magnified view centered on the initiation site, "C."

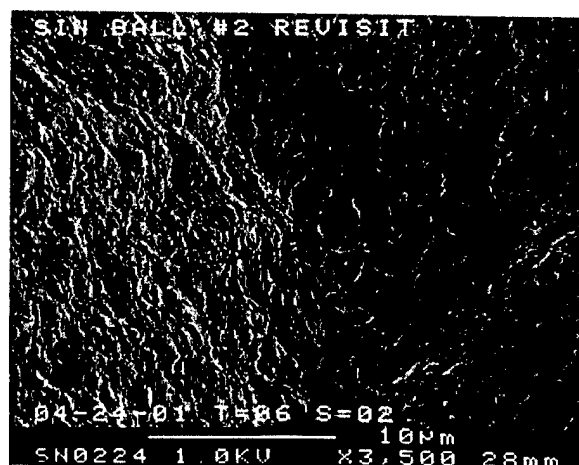
Figure 12. Magnified view of void, from which fracture initiated, that displays a different fracture appearance at the void.

The fractographic analysis of the second Si_3N_4 ball in Subsection 3.3.2 showed a small void that sits in a triangular region whose appearance differs from the fracture surface around it, which is seen most clearly in Figures 12. This change in appearance may imply that the triangular region is not the same chemistry as the material around it. For example, the region may be a pocket of segregated glassy material at the triple junction between adjacent grains of crystalline Si_3N_4 . The observation that the triangular region charges implies that the region has a higher electrical resistivity than the material around it. A higher electrical resistivity might be consistent with a pocket of glassy material rich in the sintering aids used in this Si_3N_4 . The glassy sintering aids might be expected to be more insulative than the bulk Si_3N_4 ceramic.

Alternatively, the change in appearance might imply that the triangular region possessed a different history than the material around it during the fracture process. For example, if the void does represent the initiation of the spall, then the region may be the site where a sub-critical pre-crack developed and slowly grew by fatigue over several million Hertzian loading cycles until it reached the critical size at which the rest of the spall fractured. During the course of the fatigue cycles, asperities may have been smoothed away as the opposing faces of the pre-crack opened and closed, giving the change in appearance compared to the larger fracture surface around it.

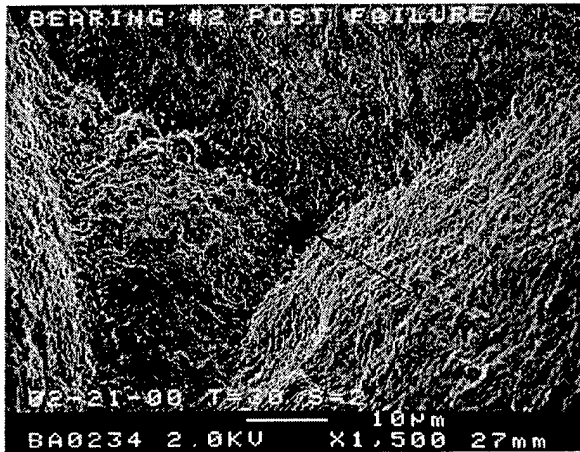
Figure 13. View sighting down the bore of the void. (The orientation is rotated from the previous figures.)

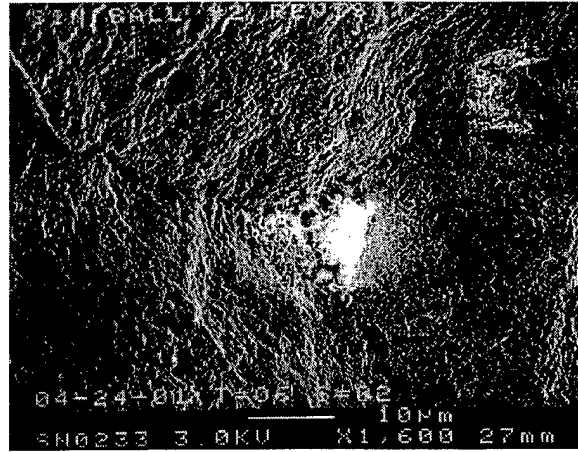
Figure 14. The void and its vicinity display charging at a slightly elevated accelerating voltage of 3 kV.

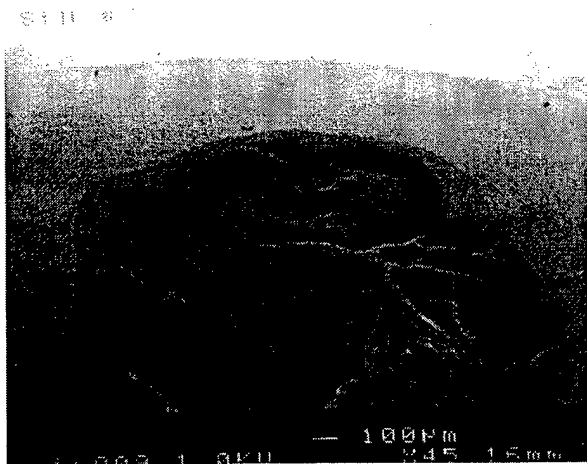
Figures 15 and 16 are low-magnification views of the entire spall. The origin of the failure appears to be a broad, flat "plateau." Circular Wallner lines radiate from the center of the plateau and down several "stepped" regions, with the concave sides of the Wallner lines pointing back towards the initiation site. The concavity reinforces the notion that the plateau is "upstream" in the fracture, and the several stepped regions are "downstream." Two features, "A" and "B," are labeled in the center of the plateau to provide landmarks, but are seen more clearly in the following more highly magnified fractographs.

Figure 15. Low-magnification view of the entire spall showing Wallner lines radiating from a broad, flat "plateau."

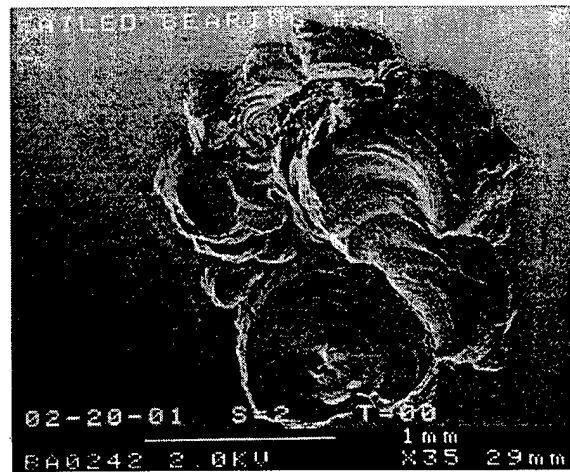
Figure 16. Another low-magnification view of the entire spall (the view is upside down from the previous figure).

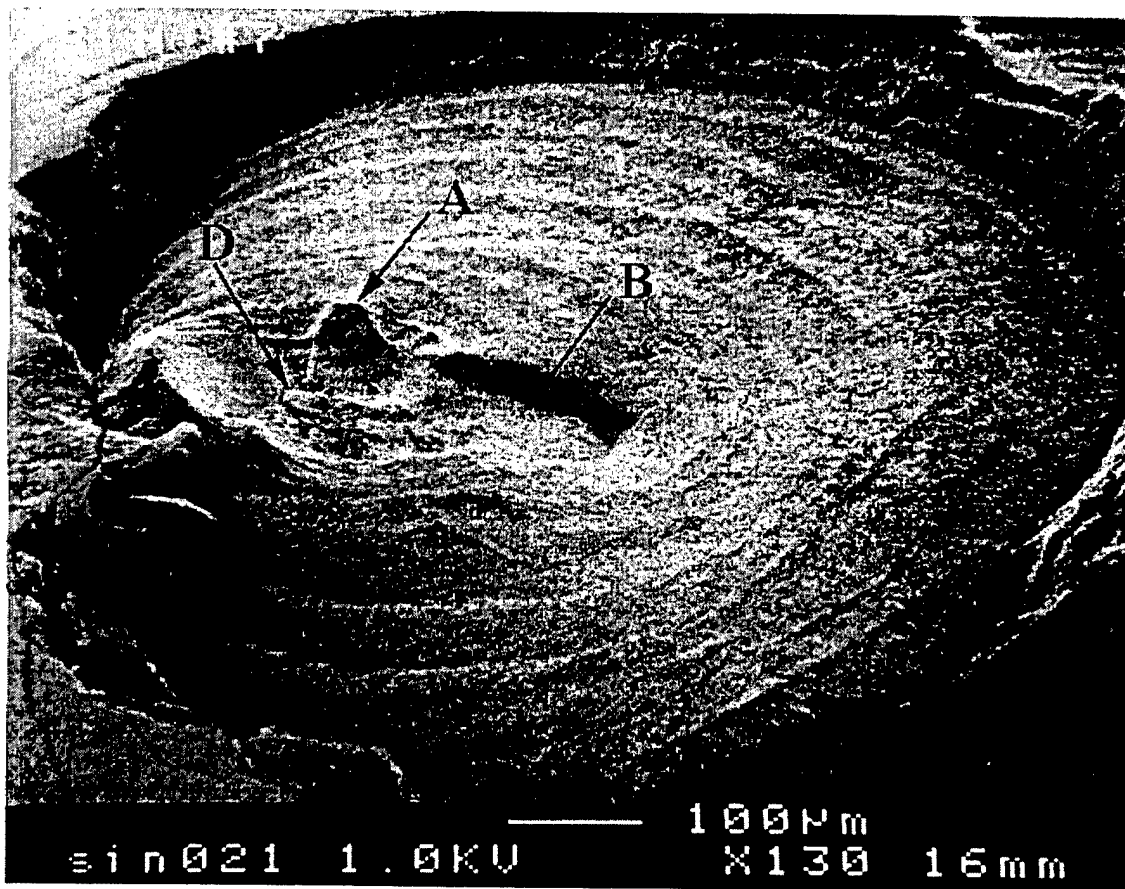
Figure 17 is a more highly magnified view of the plateau from which fracture initiated. The Wallner lines form a "bull's eye" pattern around a central point. The "thumb-shaped" feature labeled "A" is a landmark used to orient subsequent discussion. Running off from point "A" is a crack-like feature labeled "B." Another landmark is labeled "D."

Figure 17. View centered on the plateau from which fracture initiated. The Wallner lines form a "bull's eye" around a center.

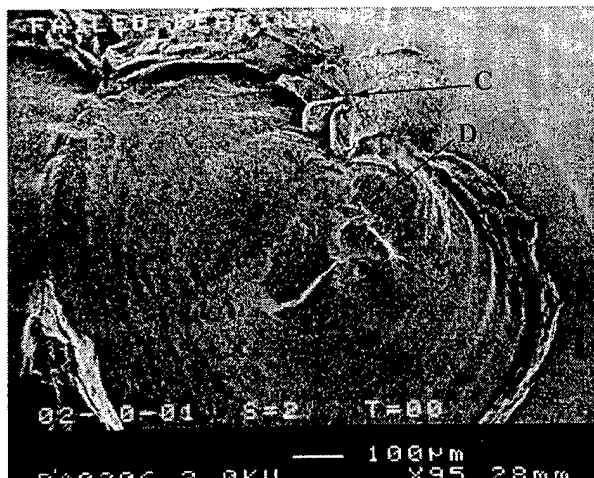
Figures 18 through 21 are progressively more highly magnified views (at 95x, 300x, 3500x, and 15,000x, respectively) of a separate crack-like feature, labeled "E," from an orthogonal perspective. Feature "E" is at the base of feature "A" near feature "D." Features "A," "B," and "D" are labeled in Figures 18 and 19 for orientation. The feature "E" is just inboard of the tightly spaced Wallner lines in the upper right-hand corner of Figure 19, which reinforces the notion that feature "E" is in the right location to be the site for fracture initiation. Figures 20 and 21 show an interesting structure in the crack-like feature "E." In the structure, ligaments span the crack-like feature. The discussion section expands upon the possible significance of the ligaments.

Figure 18. First in a series of four views centered on the initiation site.

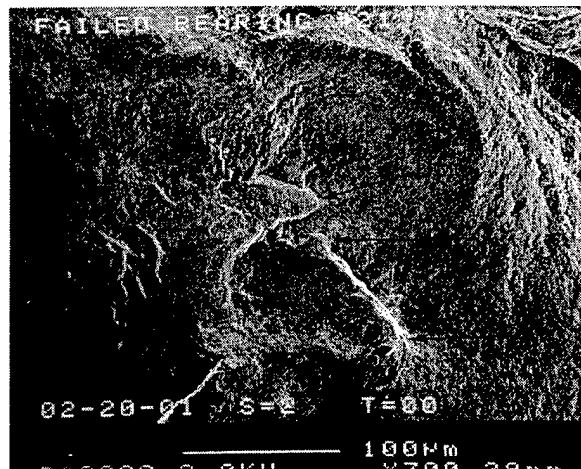
Figure 19. More highly magnified view centered on the initiation site, "E," which is just inboard of the Wallner lines in the upper right-hand corner of the image.

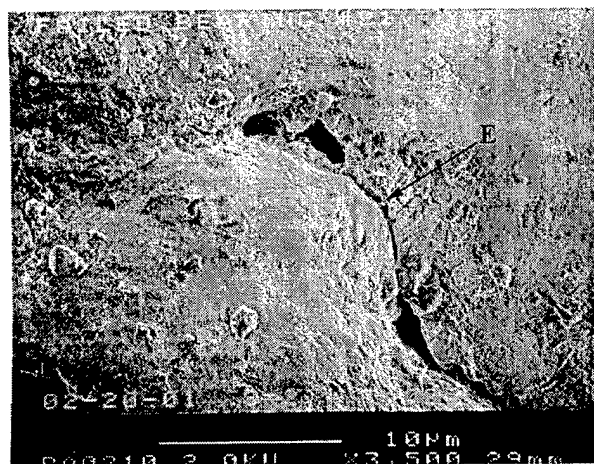
Figure 20. Ligaments span crack-like feature at the initiation site, "E."

The fractographs of the third ball in Subsection 3.3.3 show an interesting feature in the crack-like feature "E," which can be seen in Figures 20 and 21. The ligaments spanning the crack-like feature have a distinctive elliptical shape that might be characteristic of the neck that forms during sintering and pore consolidation. The neck's elliptical shape might be interpreted as the negative radius of curvature that forms at the junction between two sintered particles. That is, the ligaments may be the remnants of a string of small sintering voids that did not fully densify. If so, then the ligaments might be expected to be glassy pockets rich in the liquid-phase sintering aids used in this ceramic. It is uncertain, however, whether the ligaments represented the initiation site for the fracture, whether the ligaments developed as damage late in the fracture, or whether the ligaments were unrelated to the fracture.

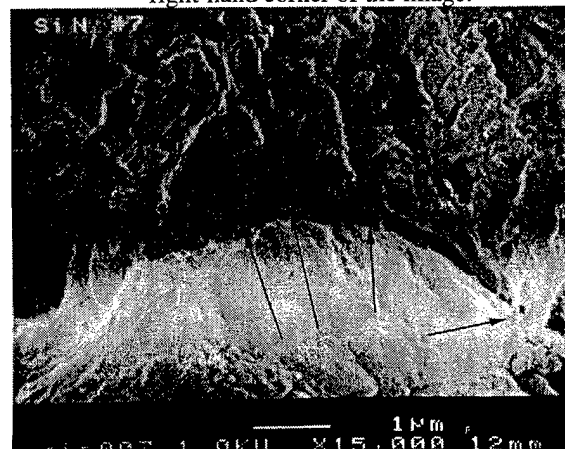
Figure 21. Highly magnified view of the string of ligaments, to which the arrows point.
